Inspection Date: 05/18/2017

HOME INSPECTION REPORT

Property Address: 1 Home Quest Way, Shelton, CT 06484.

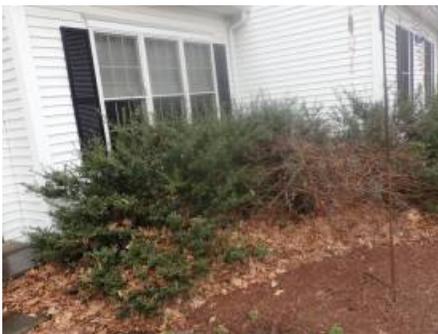
The shrubbery needs pruning. Trim all plantings away from the foundation and building. There should be a minimum of twelve inches of clearance between the shrubs and siding to prevent moisture from being trapped against the structure and causing a rotting condition.

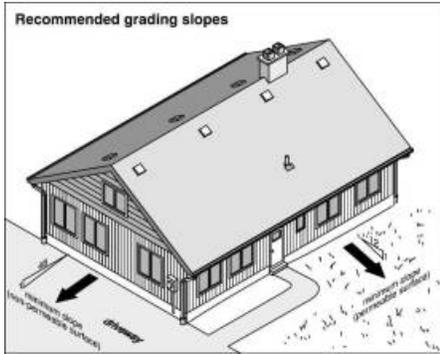
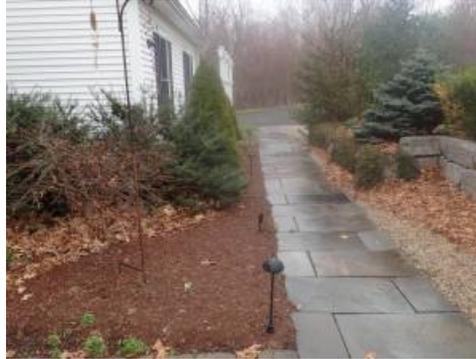
The grading is negative adjacent to portions of the foundation and water or moisture entry will remain a possibility.

Proper grading is important to keep water away from the foundation. Soil should slope approximately 1 inch per foot in a direction away from the building for at least six feet to prevent problems caused by excess water. Excess water close the foundation can cause settlement of the soil and lead to cracking of the foundation and water entry into the building. The water discharged from the gutters and leaders should be directed away from the foundation for the same reason.

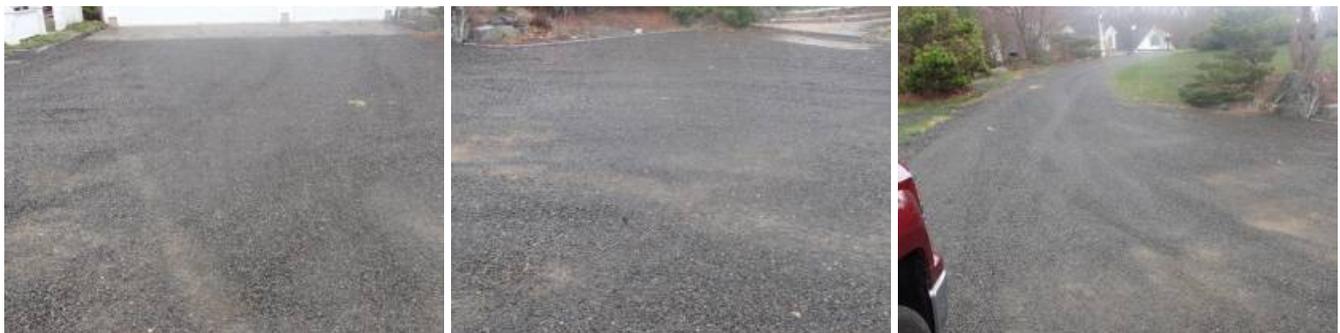
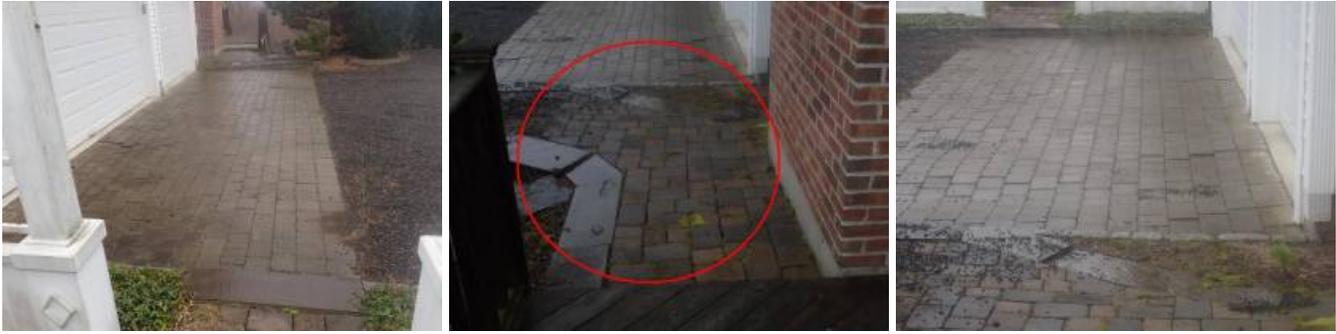
The driveway gravel surface should be redressed. Borders and edges should be defined and the surface regraded as necessary. The pavers were settled and will eventually need to be reset.

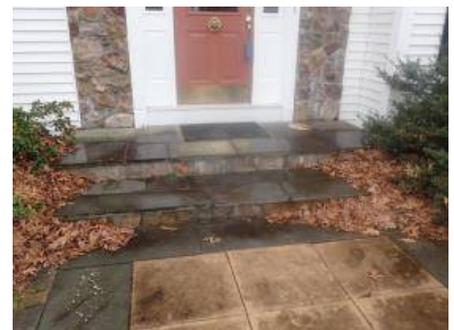
We recommend the installation of handrailings at all exterior steps with two steps or more for your safety and for your convenience. For example, consider installing railings at the front entrance steps.

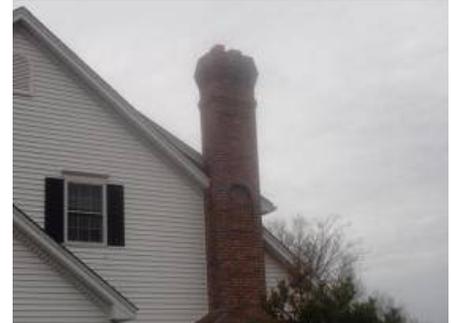
The chimney flue did not have a cap. We recommend installing a screened cap to prevent animals from nesting in the chimney and to prevent water from affecting the structure.

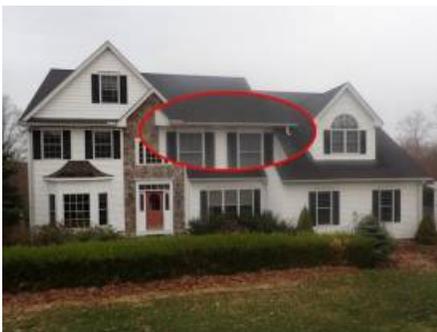
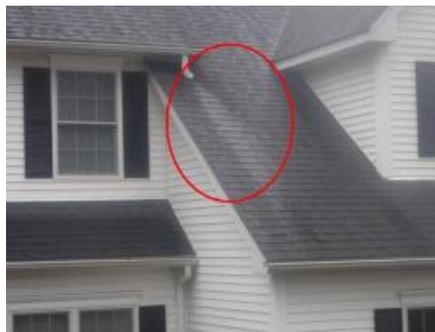
The gutters were generally in acceptable condition, however, the section of gutters at the front of the house appears to be sagging and will not drain as designed. The gutter should be remounted as required to ensure proper drainage. Gutters require regular maintenance. Periodically check all joints for leaks and caulk where it is required. All gutters should be pitched toward the leaders. Gutters and rain leaders must remain free flowing at all times.

Some of the leaders drain onto the roof surfaces. We recommend extending them past the roof surface.

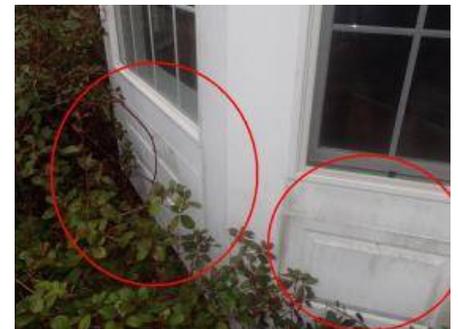
The exterior finish was stained in some areas. Although the siding material is relatively low maintenance, portions of the trim are wood and will require periodic maintenance, including repainting.

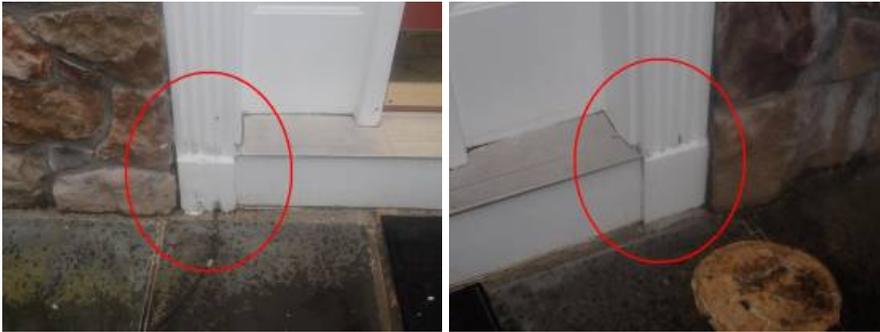
There was some wood rot observed. For example at: the front door trim. It should be pointed out that damage may exist that is not apparent because of the visual nature of this inspection. All rotting wood should be repaired as necessary. The rotted wood should be removed, and the subsurfaces should be repaired as necessary. When the subsurface is repaired, new wood should be installed, caulked and painted. Rotting wood, that is not repaired, would be an open invitation to insect infestation. When the subsurface is exposed, if any insect activity is found, it should be

treated as necessary at that time.

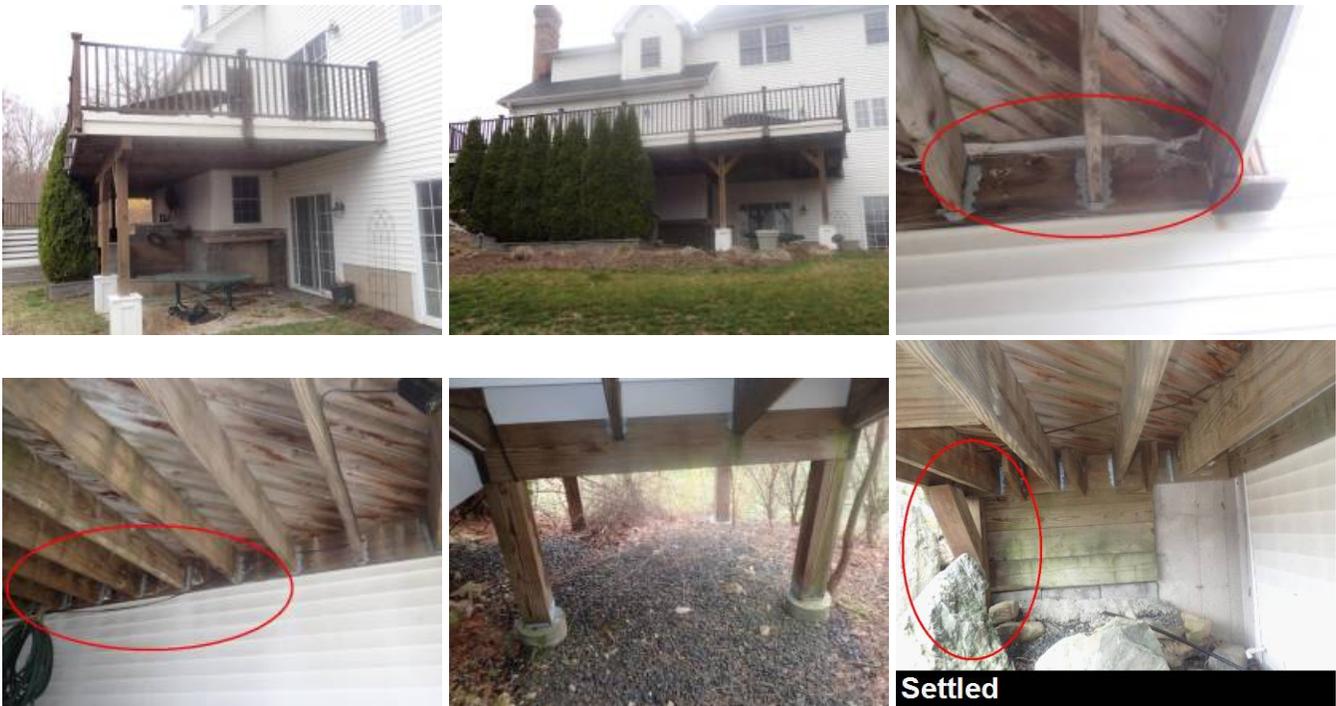
The deck appears to be adequately built. However, we were unable to determine if there is flashing installed between the deck and the siding and there is substantial staining at the ledger board. Flashings will help prevent water from penetrating into the building causing consequential damages.

The right portion of the deck appears to have settled a bit.

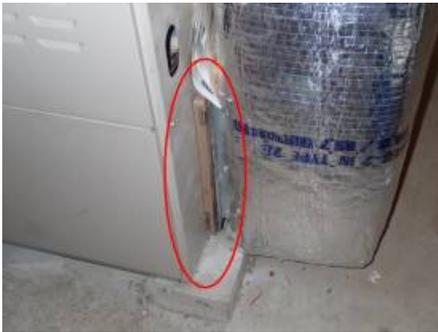
We recommend that all heating and air conditioning ducts be insulated for better energy efficiency.

All forced air systems, including ducts should be cleaned as required to help prevent possible accumulations of dust, dirt, allergenic substances, pathogenic substances and/or toxigenic substances.

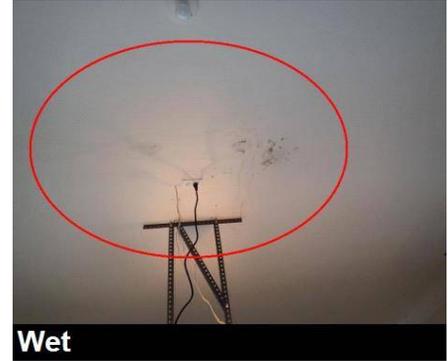
There was evidence of past leaking observed on the kitchen ceiling. Inquire with the owner as to the reason for these stains and what actions were taken to prevent a reoccurrence.

There was also evidence of active leaking observed at the garage ceiling (as indicated with a moisture meter). The source of the moisture or leaking should be identified and repaired as required to prevent consequent water damage.

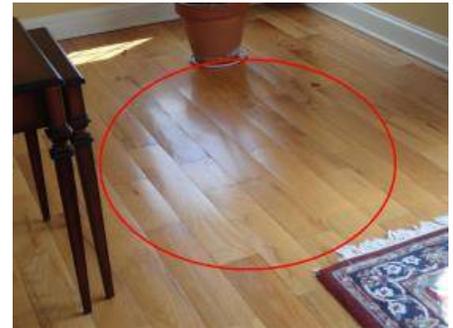
The hardwood floor in part of the family room the was found to have cupped. Floors cup like this from moisture. The source of moisture should be identified and repaired as needed to prevent further damages to the floor. We recommend repairing the floor as needed.

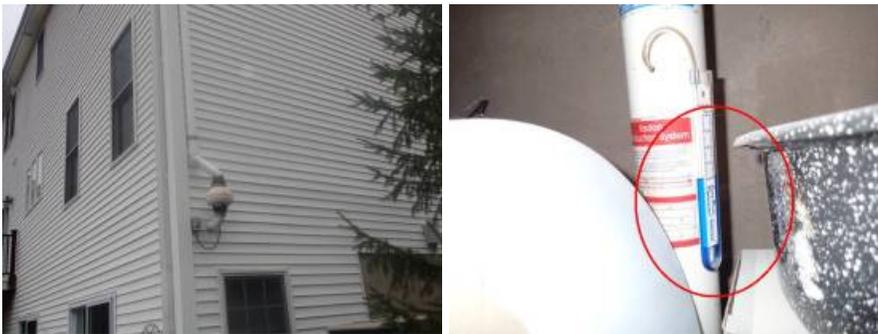
This house has been fitted with a radon mitigation system. The system appears to be in need of repairs. We recommend you contact the mitigation company to consult with them about the system. It is also recommended that the radon level in this house be tested periodically to insure the system's effectiveness.
