Inspection Date: 05/18/2017

HOME INSPECTION REPORT

Property Address: 1 Home Quest Way, Shelton, CT 06484.

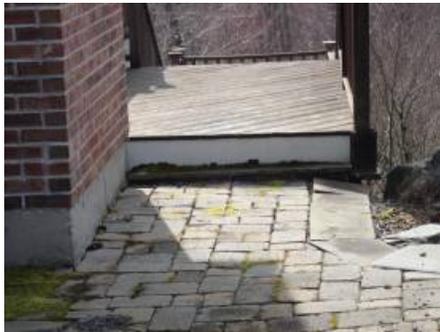
The driveway surface is gravel and pavers.

The driveway gravel surface should be redressed. Borders and edges should be defined and the surface regraded as necessary. The pavers were settled and will eventually need to be reset.

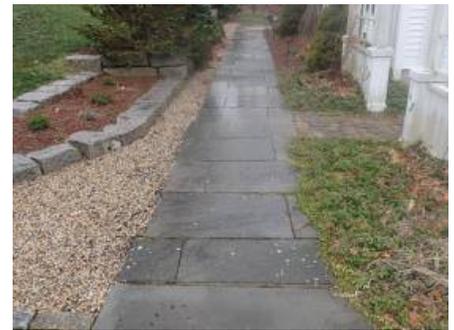
The front walk appears to be generally in acceptable condition.

We recommend the installation of handrailings at all exterior steps with two steps or more for your safety and for your convenience. For example, consider installing railings at the front entrance steps.

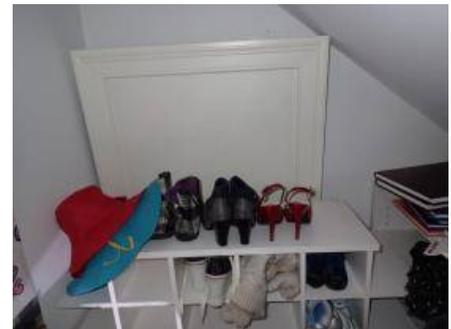
Portions of the attic have been finished inside the rafters. Because of this, the rafters, ventilation, insulation and other attic components in these areas were inaccessible for inspection. The attic is accessed by a wall hatch. Access could not be gained to portions of the attic. Therefore, no evaluation of these portions of the attic or their components could be included in this report.

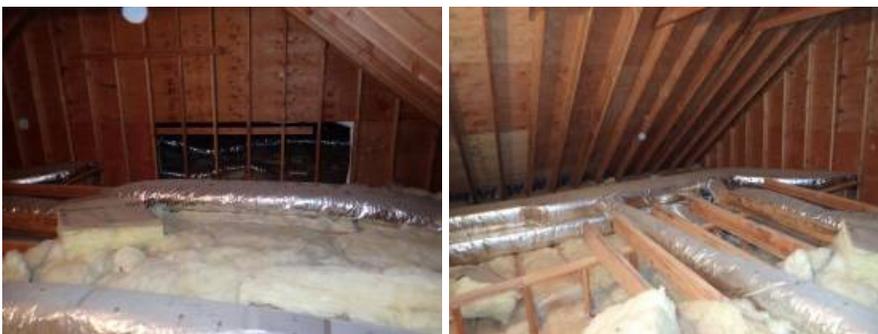
The visible roof rafters are 2" x 10" 's - 16" on center. The visible roof rafters appeared serviceable.

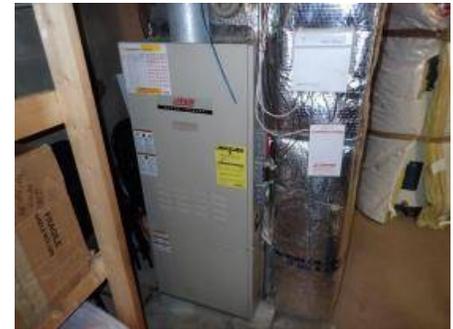
The heat is supplied by a Lennox brand, forced hot air furnace, approximately 14 years old. This type of furnace has an average design life of 15-20 years.

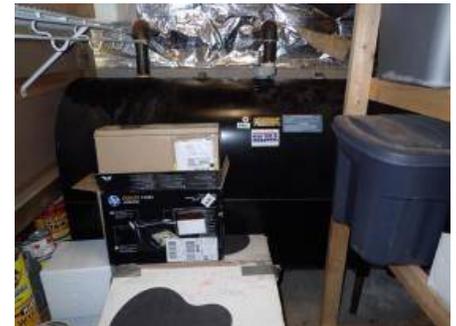
The oil tank is above ground and is located in the basement. Where visible the oil tank appeared to be generally in acceptable condition. There were no signs of significant rust or leaking observed on the exterior tank. However, oil tanks deteriorate from the inside out. Because the interior is not visible, its condition cannot be determined.

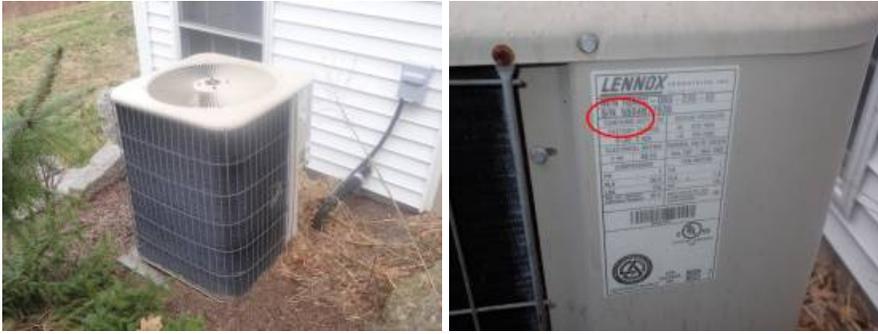
The air conditioning is provided by a Lennox brand system, that appears to be 13 years old. Air conditioning systems that are properly maintained have an average useful life expectancy of 10-15 years.

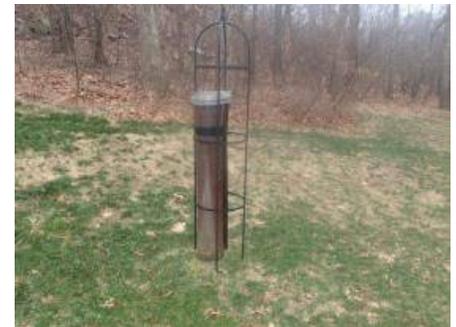
The water is supplied to this house by a private well. The well was observed in the front left yard.

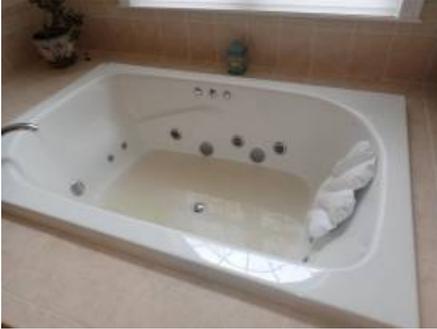
The water was discolored which may indicate a high chemical or mineral content in the water. At your request, water samples were drawn and sent to the lab for testing. You have selected the following:

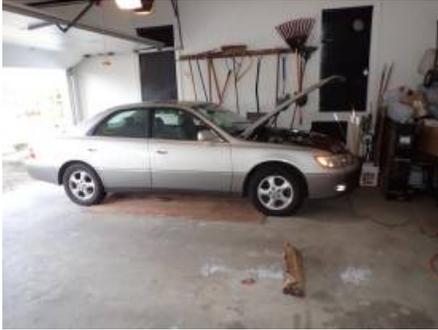
inspection. Where visible the garage appears serviceable.

We recommend installing a handrailing at the steps for your safety and for your convenience.

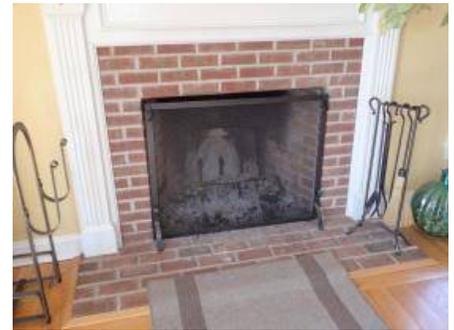
The fireplace is masonry. The fireplace appeared serviceable and should be maintained as required. This would include periodic cleaning and inspections by a qualified chimney sweep. There is a gap in the lintel joint in the fireplace. We recommend that repairs be made by a reputable and accredited chimney expert prior to further use for your safety.
